As of mid August 2005 the iron work project is within 30 days of completion. The last stairway has been erected and the cement for the steps and the landings are being poured as I write. The new pool fence is on site along with various bits and pieces needed to complete the railings, which should proceed quite rapidly after the stairway has been completed.

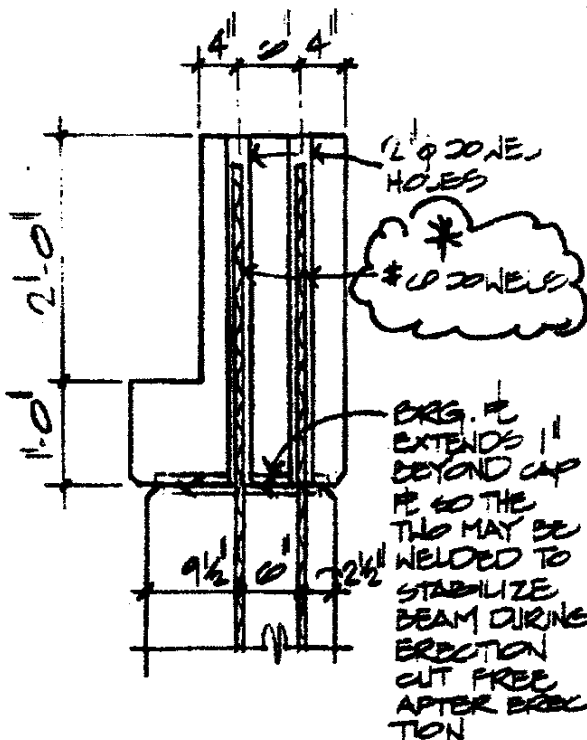
L BEAM TO 12'x 18' COLUMN

The column that had a broken beam has been replaced with two new columns to alleviate the stress on the broken beam end. The problem that is causing the columns tops to disintegrate is shown in the figure in the lower left on page 3. The welds that were made during initial construction to hold the beams in place were supposed to be wiped clean after they were loaded with the tees that form the base of the first floor. Removing these welds was paramount to allow the beams to move with the ordinary expansion and contraction due to normal temperature variations. Because these welds were not removed expansion and contraction actually was transferred to the 1.25 inch Ibar in the corner of each column and/or the steel plate embedded in the beam end, consequently breaking one or the other. This problem was not apparent until the top of the column was removed. In order to do this the garage floor had to be removed so supports could be placed onto the piling caps, which support the columns, which in turn support the building. This particular column is located almost directly under a firewall and is probably one of the most heavily loaded columns in the building (approximately 700,000# or 35 tons), so this project was attempted with much circumspect.

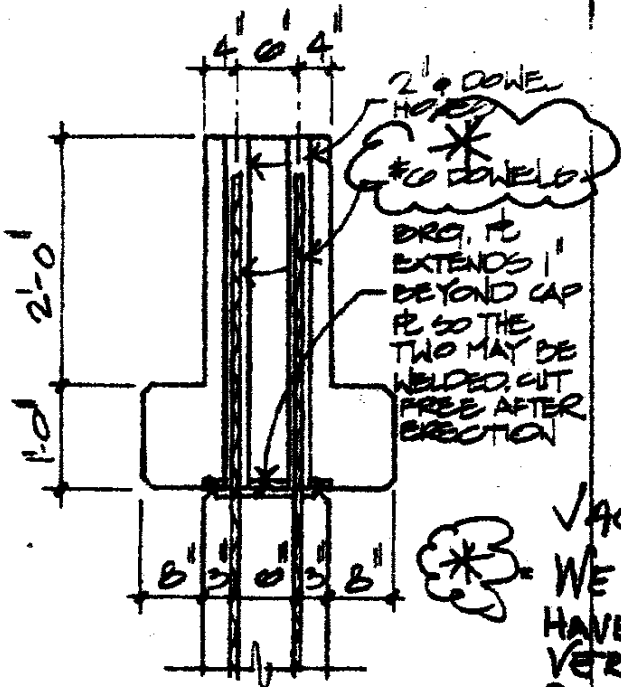
INVERT. TEE TO 12' COLUMN

✓ JACK:
 WE DO NOT
 HAVE THE
 VERTICAL
 DOWELS.
